August 29, 2016

Subject: Block Island Power Company - Engineering Review

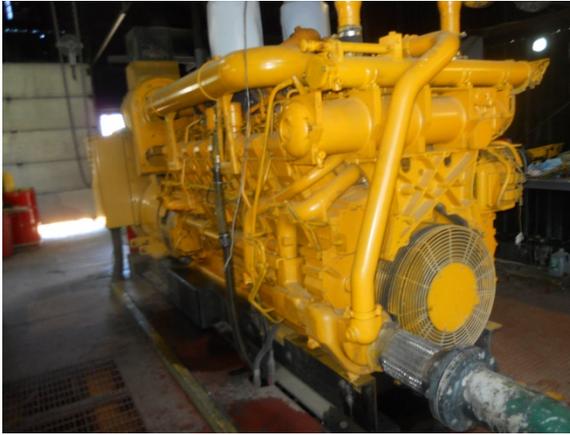
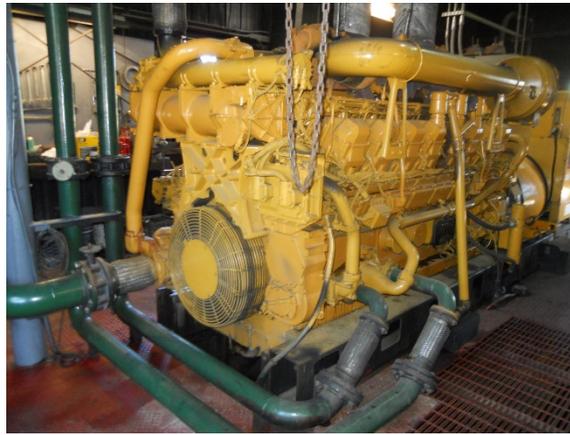
#24 and #25 were inspected while running with no apparent issues. Although not pristine, they appeared to be well maintained, and the building was also adequate for the operation.

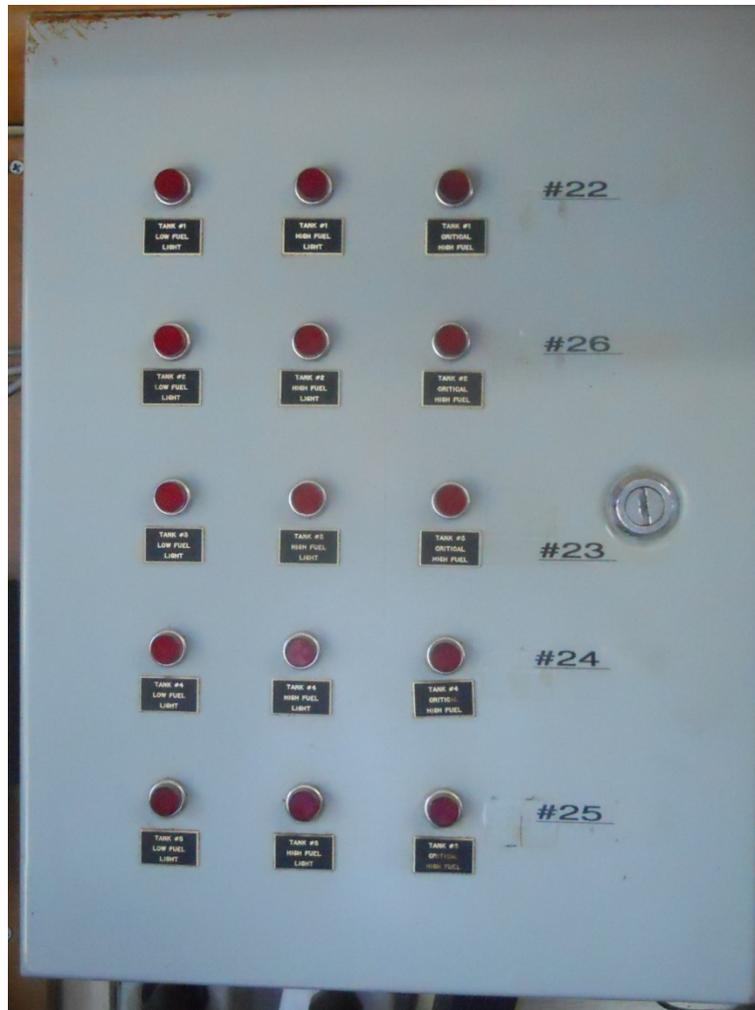
Each generator has a day tank for the diesel it uses. Diesel is continuously pumped to the diesels, and a high proportion is returned. An alarm panel is located in the control house to facilitate quick response to day tank failures.

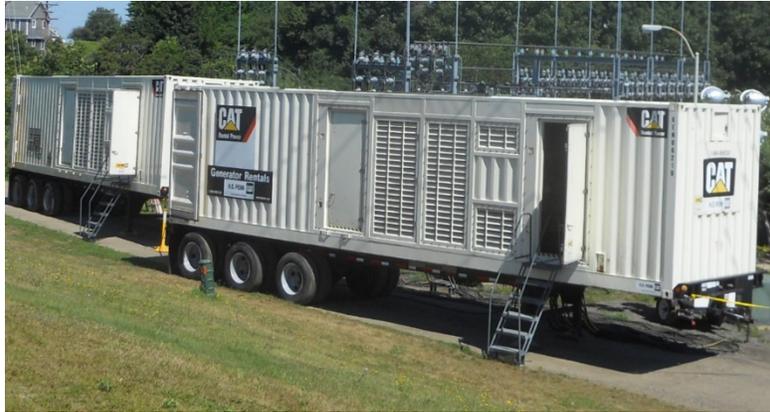
In order to continue to supply power to the island BIPCO contracted with Caterpillar Milton to supply two trailer mounted generators capable of 2 MW each. According to BIPCO management, the transformer capabilities were less than the total of 4 MW which was available, because of availability of transformers for immediate delivery. It was reported that larger transformers were enroute, to bring these generators up to full potential. The temporary generators were interconnected to the substation bus, with appropriate isolation disconnects. Because this was a temporary situation, these were not evaluated as part of the assets of BIPCO.

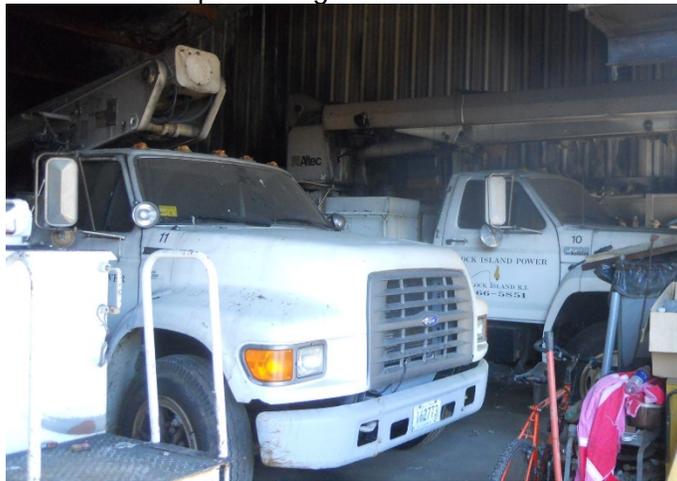
Three BIPCO line trucks were parked in the other section of the generator building that sustained a fire. It was reported, and evident to a casual observer, that one truck had significant heat related damage. Due to age and condition of the truck before the fire, and the fire damage, it is expected that this truck will be a total loss. The other two line trucks had visual damage to some degree, but appeared to be serviceable. BIPCO plan is to have the local Ford dealer get the truck back in service so it can be driven to the bucket equipment manufacturer. The manufacturer will perform a complete inspection and advise what service is required to get it back to a safe and serviceable vehicle.

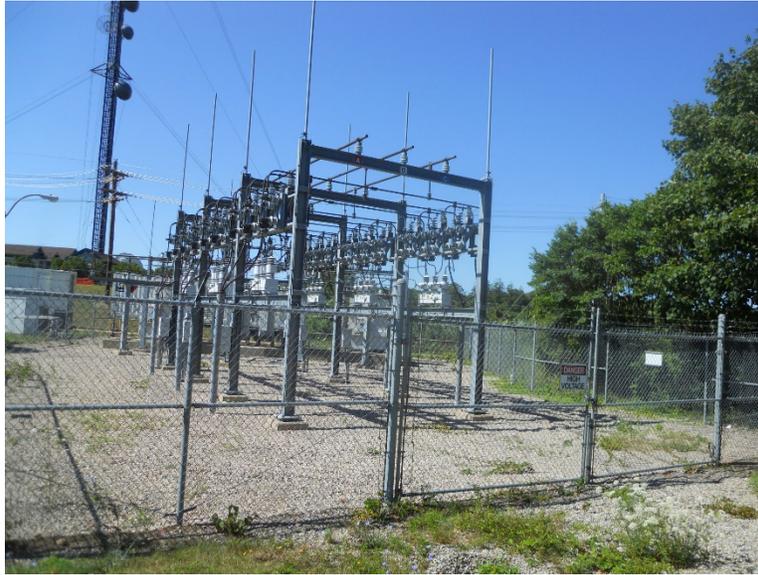
Power is delivered to one of two primary transformers with output to a common buss. Power regulators discharge power to the main distribution buss. From the distribution buss, the substation has six distribution circuits:

A review of the documentation for the substation indicated that the drawings and component information needed for service was readily available. The general condition of the substation looks very well kept up with no obvious safety or maintenance issues. Daily inspections of the substation are performed by BIPCO employees, with annual service performed by Haugland Energy. The last inspection and service was done in January 2016, with several recommendations made. (See Attachment for the letter report.) Upon questioning BIPCO management, it was determined that **none of the recommendations had been completed**. BIPCO management reported that parts were on backorder. Because annual service and maintenance is necessary to discover hidden problems, this could indicate a potential reliability of safety issue for the facility.

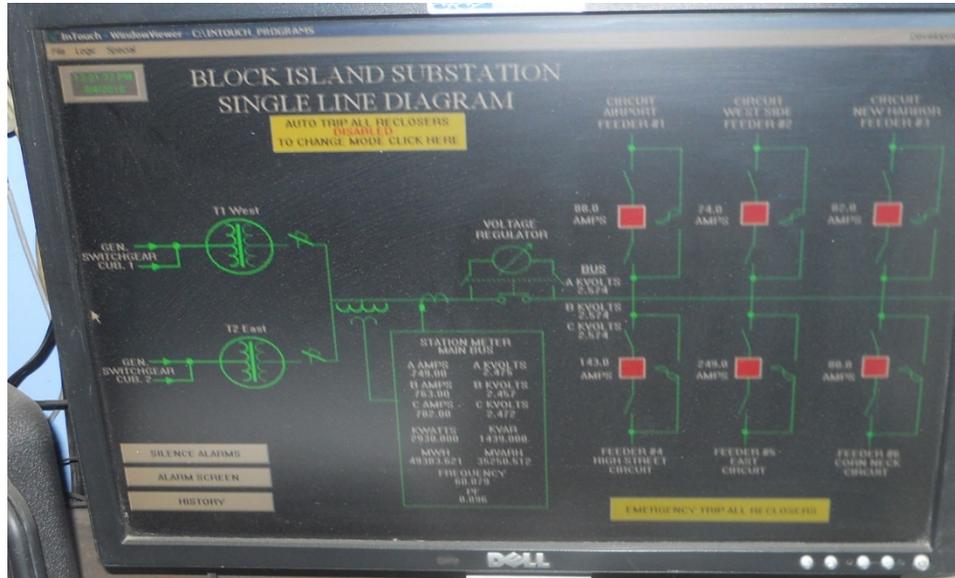
The substation is monitored via a fiber optic link by the Substation computer. From this screen, breakers can be operated remotely, and other key parameters can be monitored. As shown below, the distribution buss is shown to be at 2.574 kV.

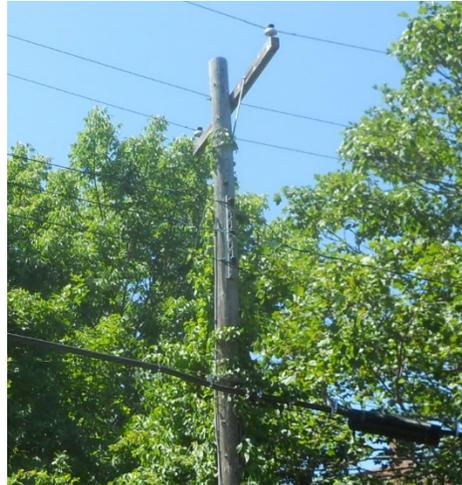
A limited inspection of two distribution lines indicated that maintenance, especially vegetation trimming was being neglected. The picture below shows conductors touching vegetation as well as vines growing right up to the crossbars.

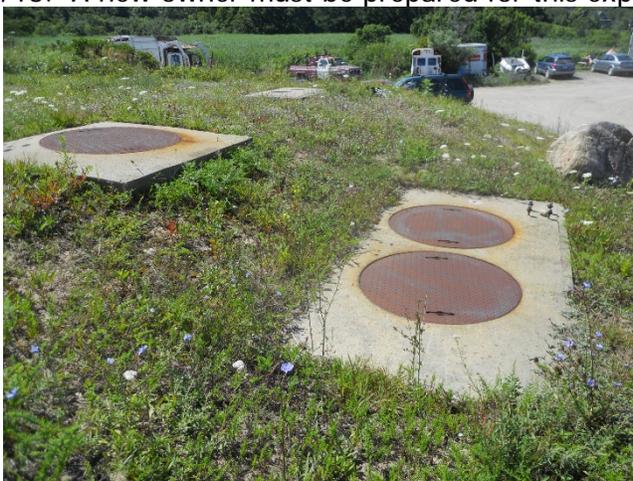
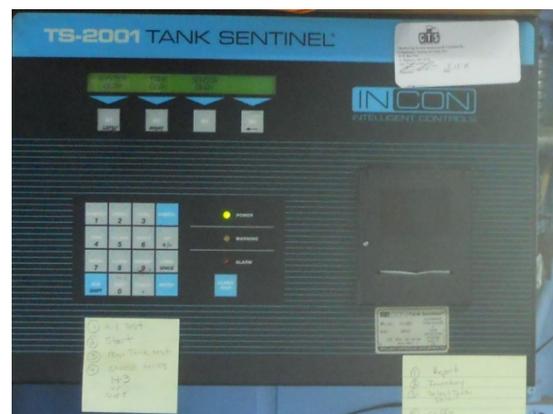
BIPCO has several underground diesel fuel oil tanks, all monitored from a remote panel in the control house. It was reported that all tanks must be removed, by order of the US EPA. One group reported the deadline was 12/31/16 and another reported the deadline had been extended to 12/22/17 or 1/1/18. A new owner must be prepared for this expense.

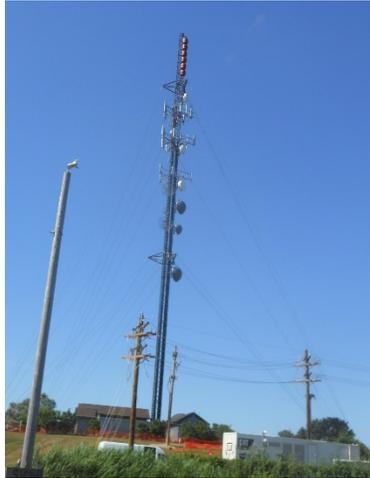
There is a cell tower located on the site, which appeared to be in good condition with no immediate areas for concern. It was reported to be owned by BIPCO with space leased to Verizon, ATT, Sprint, Cingular, and one or two radio stations. It was reported that the tower was originally constructed by one of the radio stations, but ownership transferred to BIPCO, at a later date. It was reported that annual inspections and service were performed by Northeast Towers Inc.. There were no records of the inspections available to review.

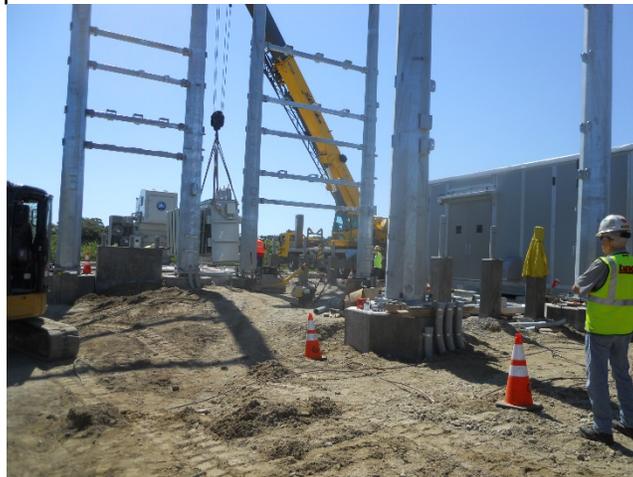
National Grid has installed a subsea cable connecting their mainland transmission to Block Island. The subsea cable, the underground Block Island cable and the overhead BIPCO property line have been installed. National Grid is currently constructing a substation on property it has purchased from BIPCO on the BIPCO site, for the purpose of supplying power to BIPCO and to the Deepwater Wind project. No evaluation of this were performed.

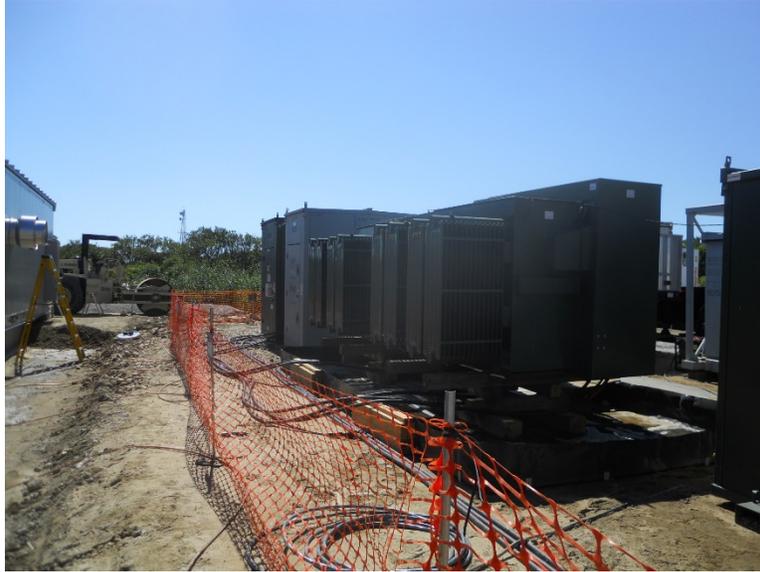
and National Grid share the transmission line corridor on the island. Deepwater Wind is constructing its own substation, immediately adjacent to the National Grid substation on land it has purchased from BIPCO on the site. In addition, Deepwater Wind has installed a temporary Micro Grid to energize the turbines during commissioning. The Micro Grid was connected temporarily to the Deepwater Wind overhead line. It was reported that this line was not yet energized.
