New Shoreham, Rhode Island
PREPARED FOR:
Town of New Shoreham
P.O. Drawer 220, Block Island, Rhode Island

SEA LEVEL RISE ADAPTATION STUDY
Field Review of Impacts from Sandy

SHT NO.
A-9
OF

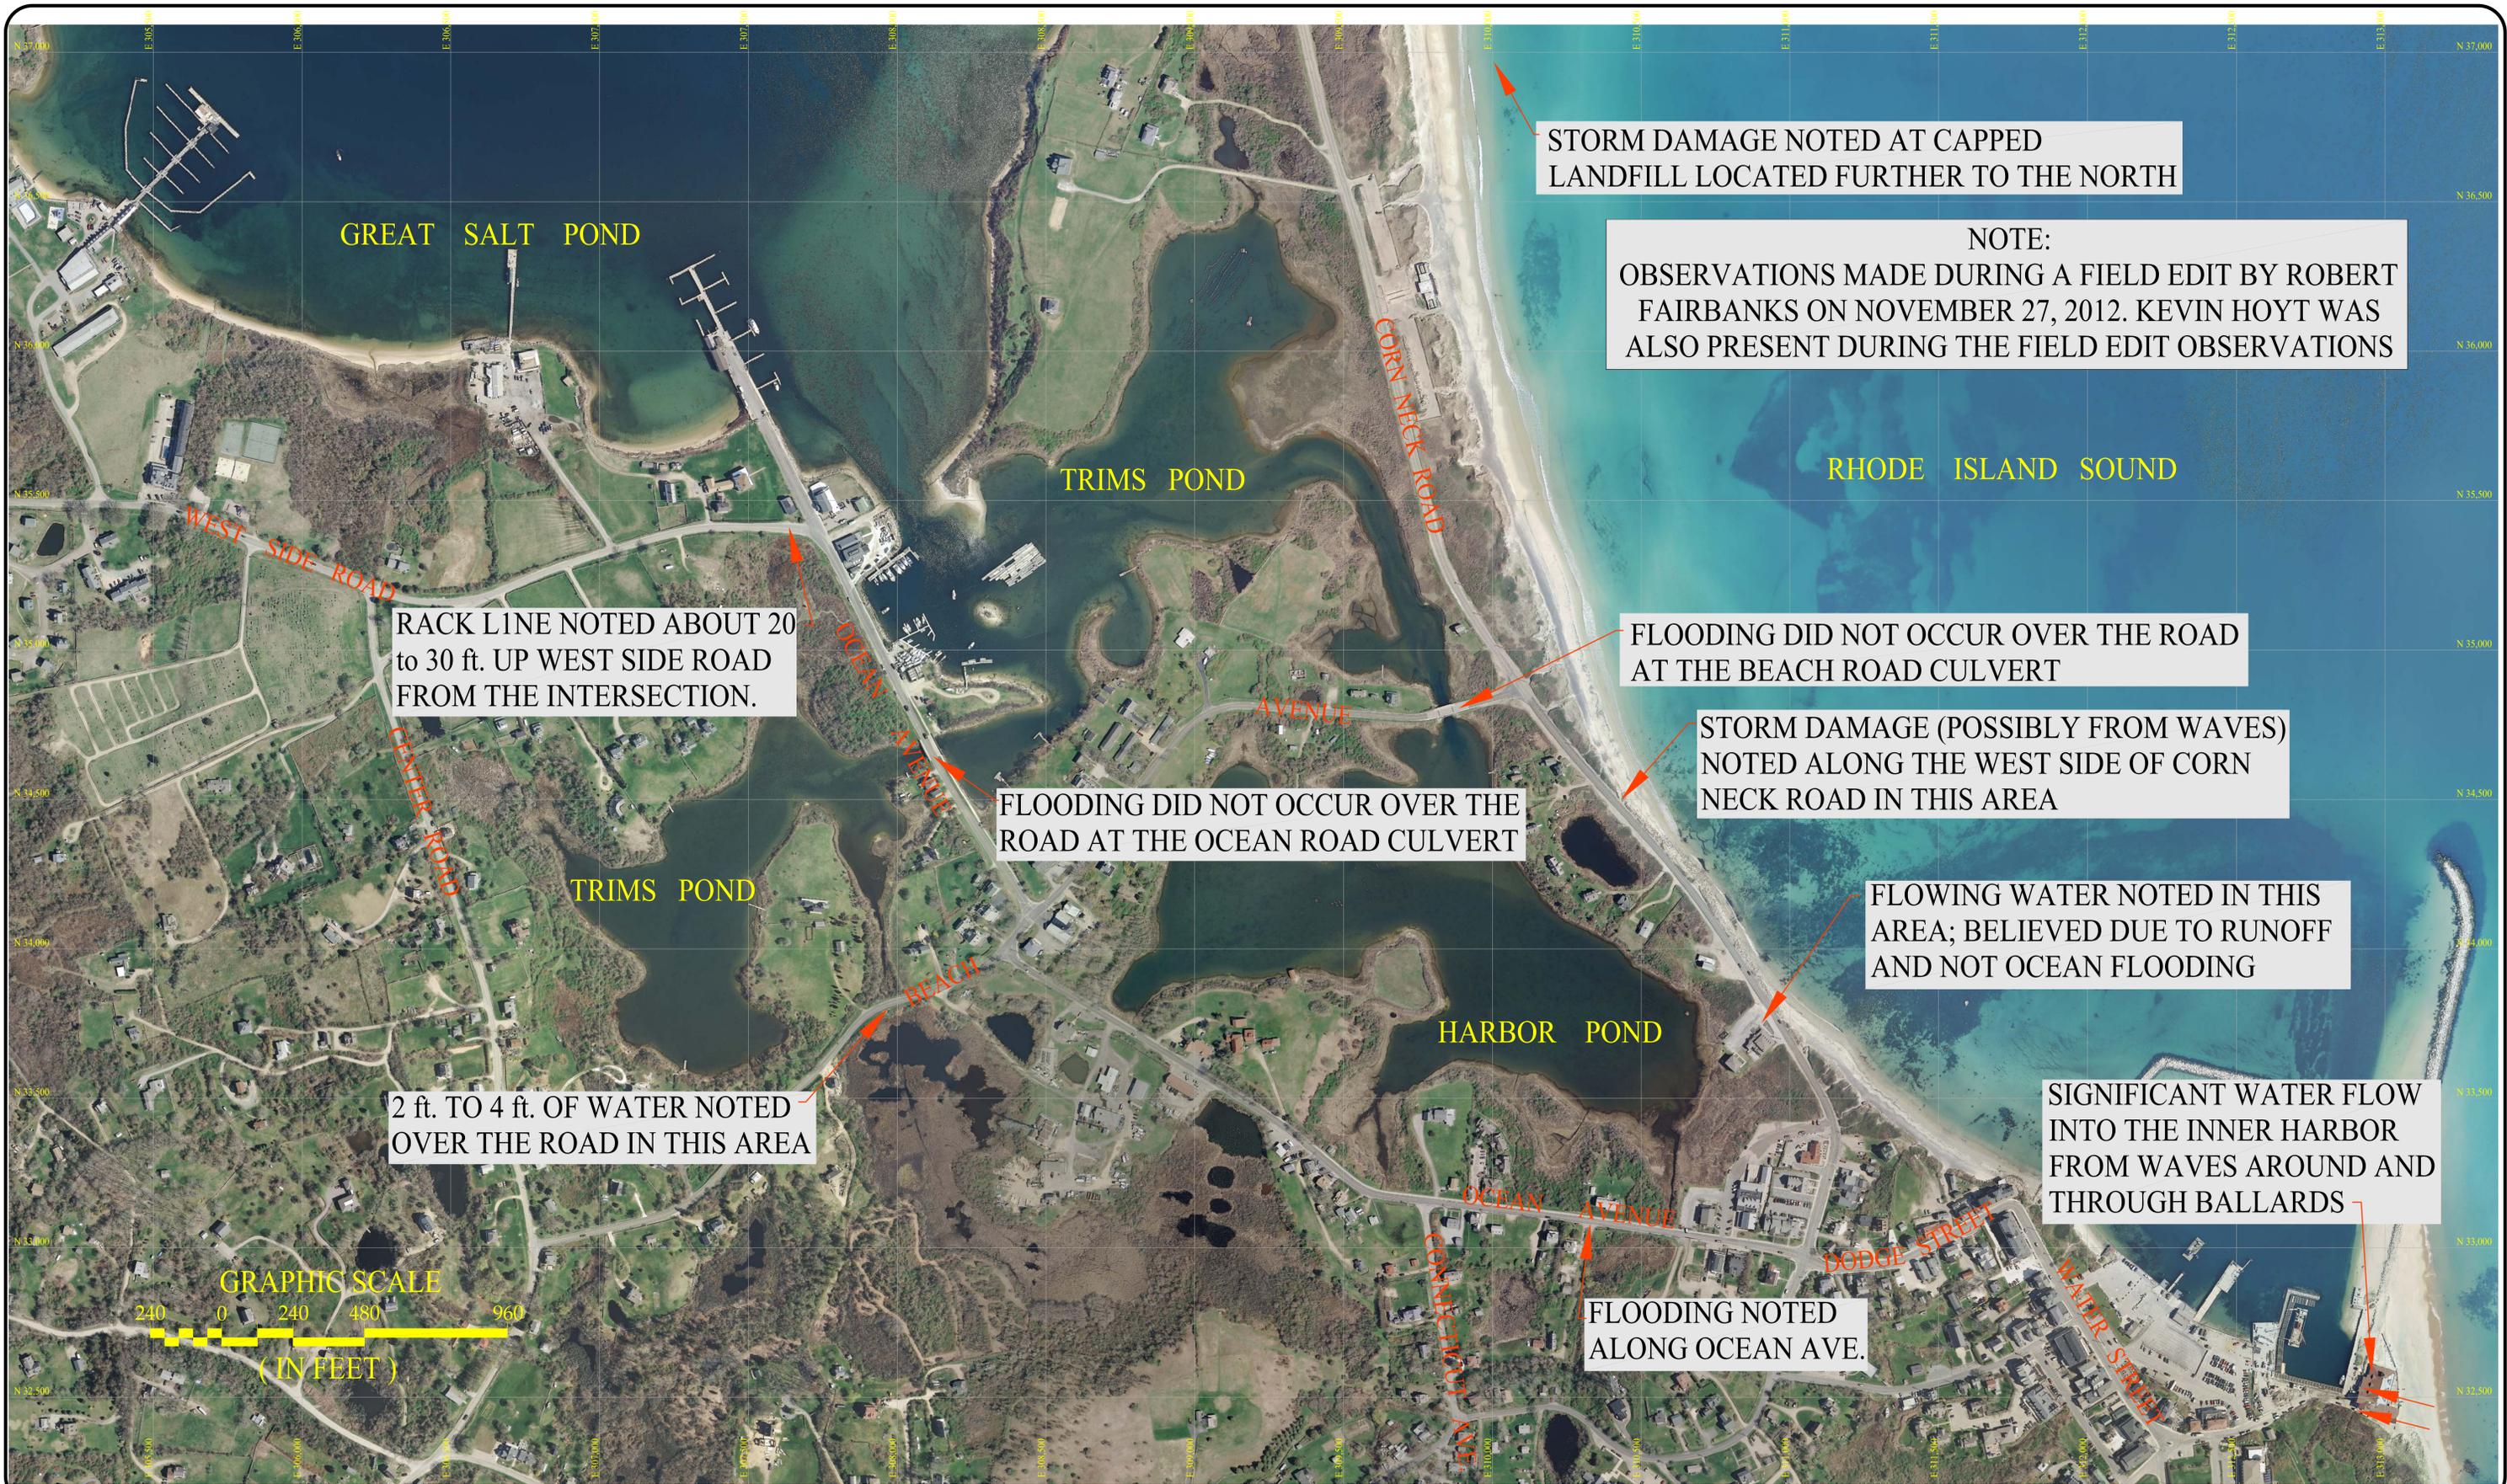
STORM DAMAGE NOTED AT CAPPED LANDFILL LOCATED FURTHER TO THE NORTH

RACK LINE NOTED ABOUT 20 to 30 ft. UP WEST SIDE ROAD FROM THE INTERSECTION.

FLOODING DID NOT OCCUR OVER THE ROAD AT THE BEACH ROAD CULVERT

STORM DAMAGE (POSSIBLY FROM WAVES) NOTED ALONG THE WEST SIDE OF CORN NECK ROAD IN THIS AREA

FLOODING DID NOT OCCUR OVER THE ROAD AT THE OCEAN ROAD CULVERT

FLOWING WATER NOTED IN THIS AREA; BELIEVED DUE TO RUNOFF AND NOT OCEAN FLOODING

2 ft. TO 4 ft. OF WATER NOTED OVER THE ROAD IN THIS AREA

SIGNIFICANT WATER FLOW INTO THE INNER HARBOR FROM WAVES AROUND AND THROUGH BALLARDS

FLOODING NOTED ALONG OCEAN AVE.
