**PHASE I
ENVIRONMENTAL SITE ASSESSMENT**

**Block Island Power Company
Ocean Avenue
Assessor's Plat 17, Lots 35, 36, 37 & 40
New Shoreham, Rhode Island**

SAGE Project #S2671

September 15, 2016

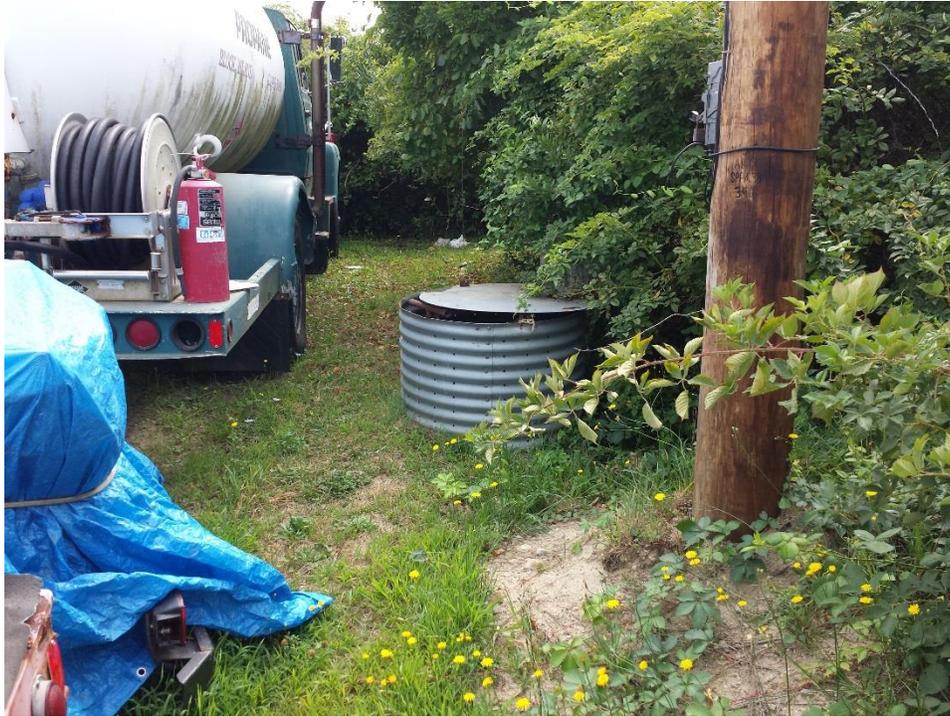
View of the recovery well (RW-3) located along the southern portion of the Site. This is part of the groundwater interception trench located in this area.

- One inactive recovery well, identified as RW-3, is located along the southern portion of the lot, adjacent to the wetlands. This recovery well is associated with a groundwater interception trench. Upon inspection, standing groundwater was observed in the recovery well; however, neither a petroleum odor or sheen was detected.

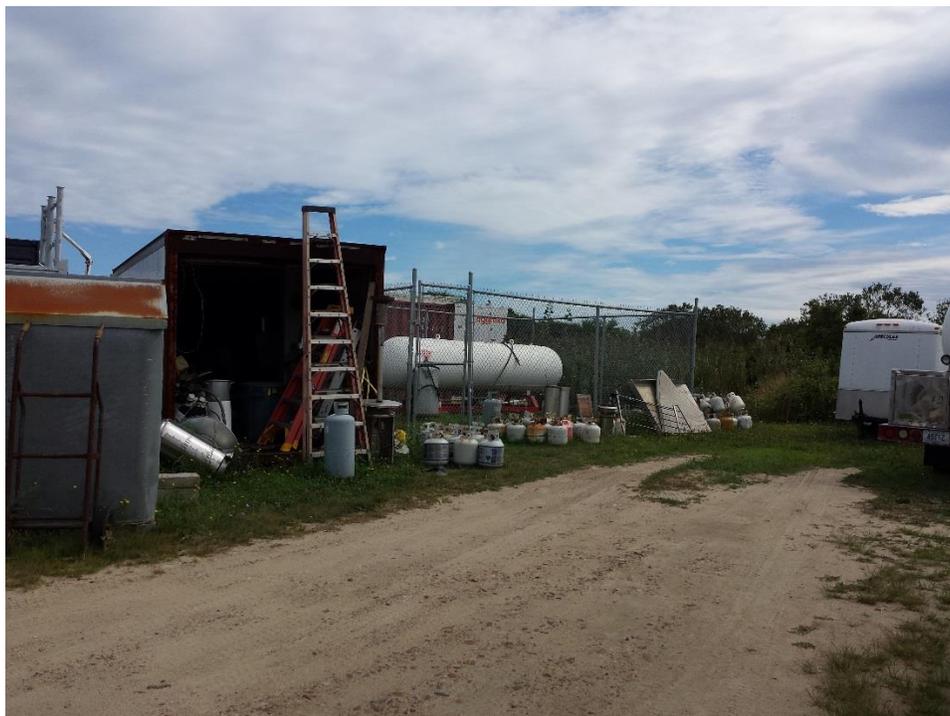
View of the area of lot 37 used for propane storage by an outside contractor.

- Several small propane tanks (approximately 20-pounds) and a larger propane AST of unknown size are located on the southeastern portion of the lot. According to BIPCO representatives, this portion of the Site is rented out by an outside contractor. **As such, no additional investigation of the noted propane ASTs is recommended.**

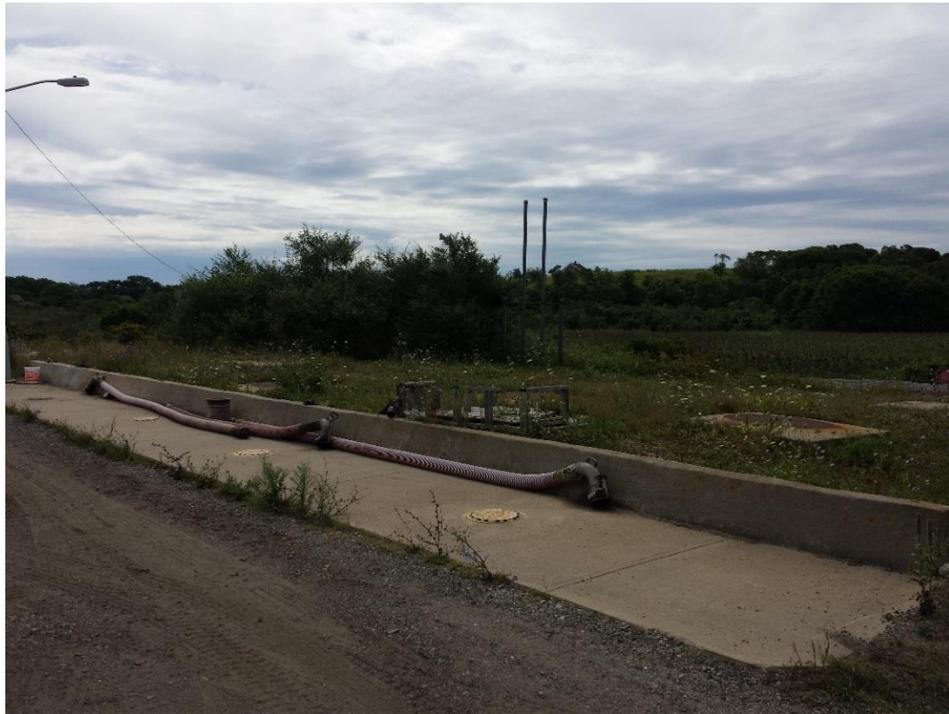
View of the area containing the five (5) active USTs. This is also the area of the historic tank field.

- “Five (5) Active USTs” – According to BIPCO representatives, the USTs must be removed by December 2017, as directed by RIDEM personnel. While groundwater in the vicinity of the USTs is monitored and the USTs have passed the most recent tank tightness tests, the volume of petroleum stored is considered a significant environmental concern. During the proposed removal process, residual petroleum contamination may be mobilized due to disruption of the subsurface environment. **SAGE recommends monitoring and potentially reactivating the recovery well during and post-tank future removal to minimize and prevent further contamination from entering the adjacent wetlands. Additionally, SAGE recommends collection of groundwater samples from hydraulically downgradient monitoring wells to confirm results reported in previous quarterly groundwater monitoring reports conducted by BIPCO.**

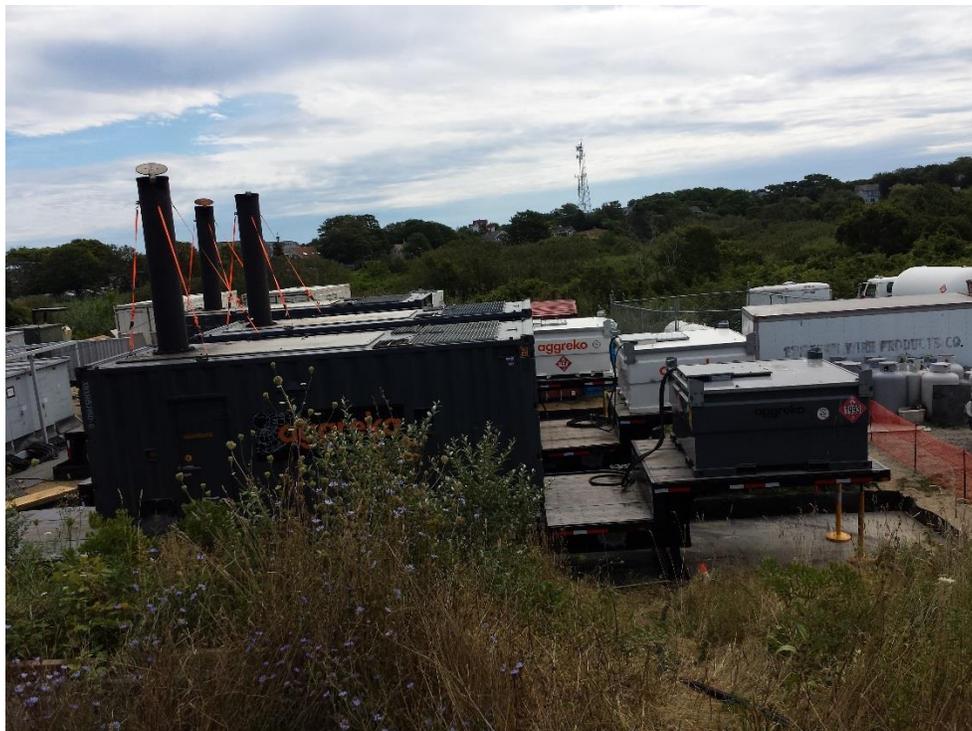
View of the construction of the new substations at the Site.

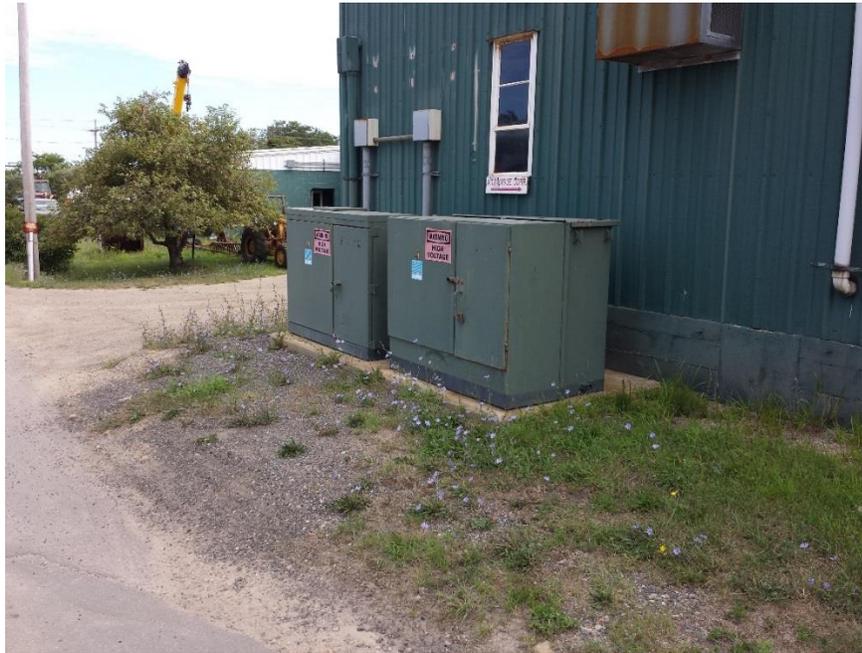
View of pad-mounted transformers. Several of these are located throughout the Site.

- Several pad-mounted transformers were observed on the lot. A sticker was present on each transformer certifying that the dielectric fluid within each transformer was tested to determine the amount of PCB content in the fluid. According to these stickers, the fluid contained less than 50 ppm of PCBs and is classified as a non-PCB transformer. No visual evidence of leaks associated with the transformers were observed to have impacted the ground adjacent to the transformers. **As such, no additional investigation of the noted transformers is recommended.**

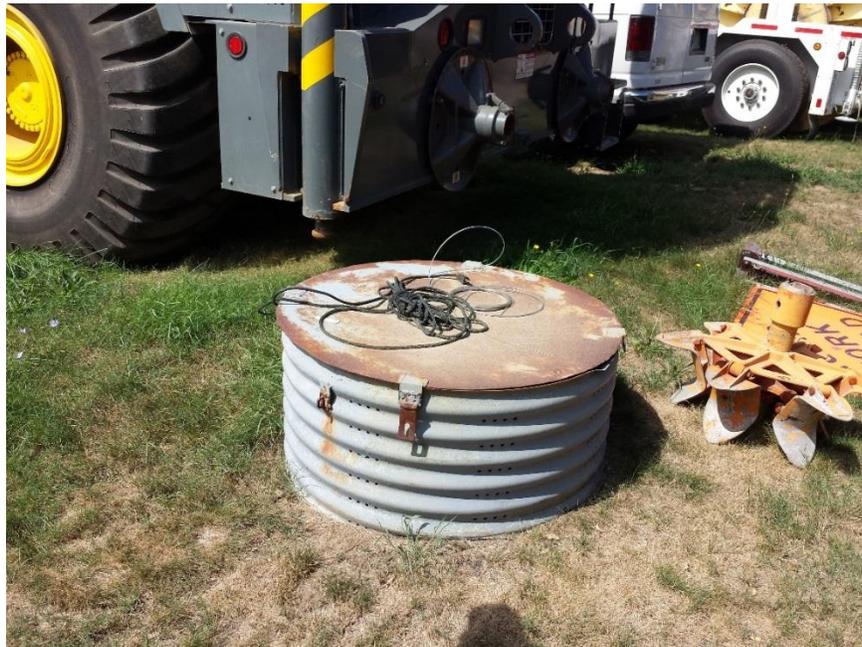
View of the recovery well RW-1 located along the northern portion of the Site. This is part of the groundwater interception trench located in this area.

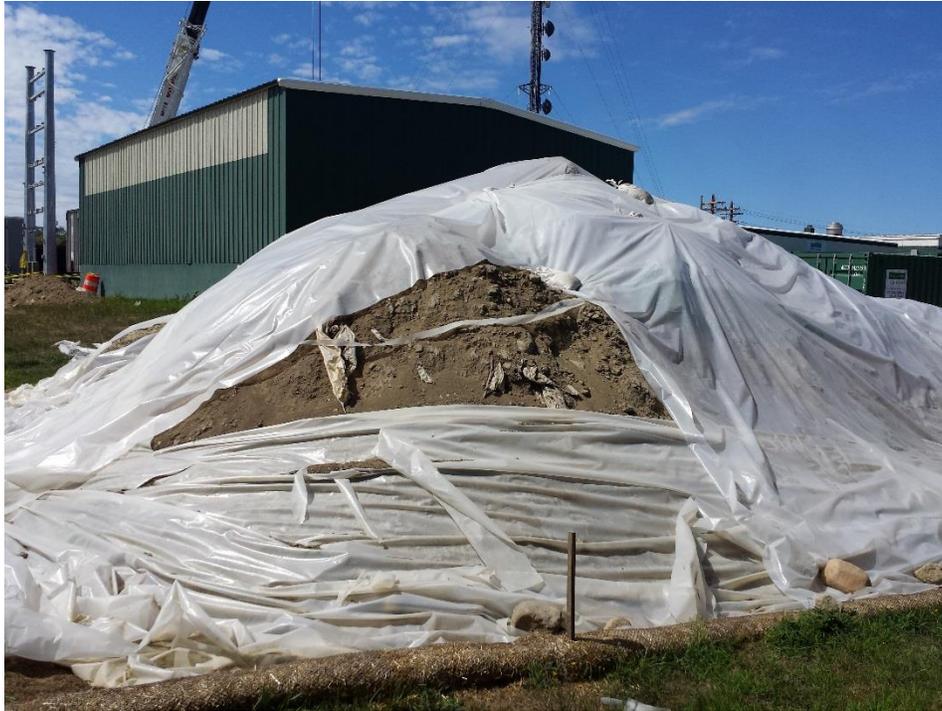
View of the soil pile generated during the construction of the new substations.

- A soil pile generated during the construction of the substations is located on the northern portion of this lot. According to reviewed files, the volume of the soil pile is between approximately 400 and 800 cubic yards. On July 20, 2016, Coneco Engineers and Scientists (Coneco) collected seven (7) 9-point composite soil samples, designated DCS-01 through DCS-07, from throughout the stockpile generated from substation construction activities underway at the Site. The stockpiled material was noted to consist primarily of gravelly sand fill material and organics (peat). No evidence of anthropogenic fill material was observed. A reviewed laboratory analytical report for samples collected from the soil pile on July 20, 2016 indicate that six (6) of the seven (7) samples were submitted for laboratory analysis of total petroleum hydrocarbons (TPH) and total lead, which appear to be the main COC. The remaining sample was submitted for landfill disposal parameters (TPH, RCRA 8 metals, SVOCs, VOCs, PCBs, ignitability, total sulfur and total cyanide). Of the submitted samples, no detections in excess of RIDEM R-DEC or GA-LC were identified. TPH

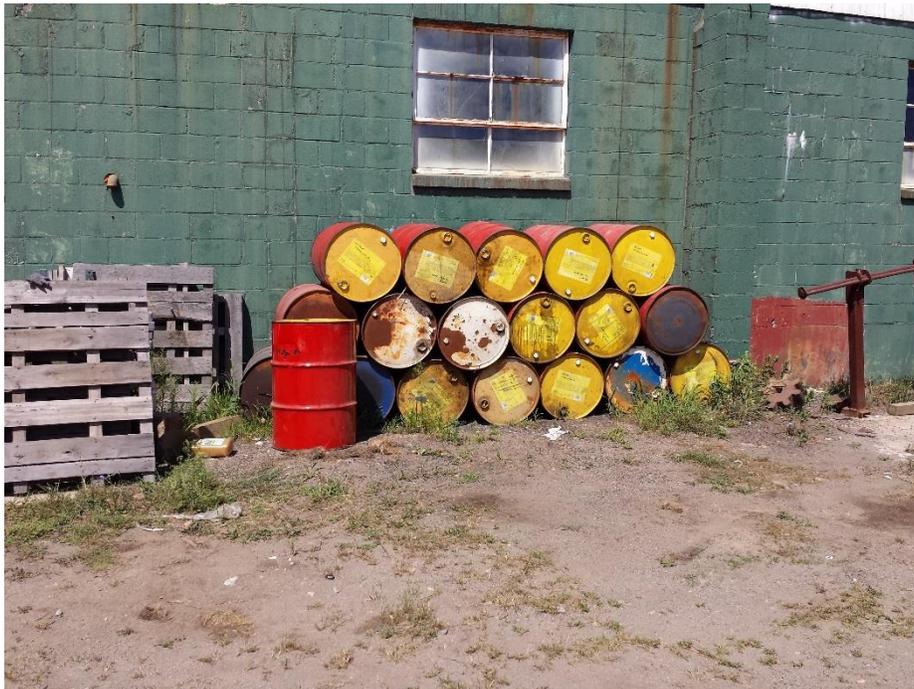
View of empty 55-gallon drums used to store oil at the Site, located on lot 36.

- Several empty 55-gallon containers of used/waste oil were observed to the east of the equipment storage and partial office building. The drums are stored on bare ground; however, no signs of petroleum staining on the adjacent grounds were observed. **SAGE recommends that storage of any drum that formerly or currently contains petroleum product be stored indoors to minimize environmental risks. Additionally, SAGE recommends collection of groundwater samples from active monitoring wells located in proximity of the drums to assess whether any objectionable impact may have occurred from the drum storage.**

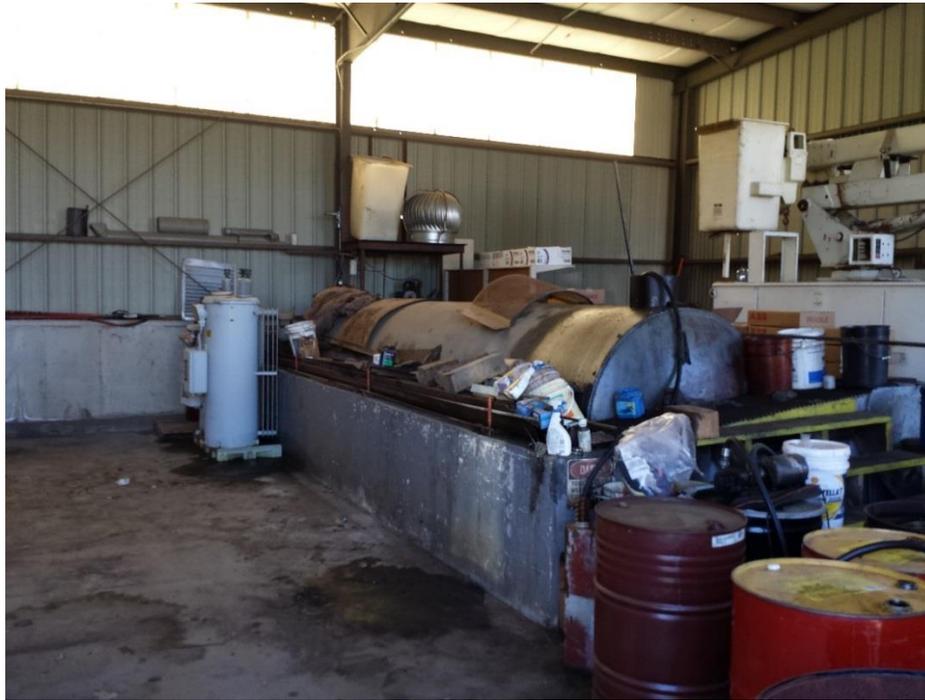
View of the interior of the “DEM Building” located on lot 37.

- A Site building, located along the northeastern portion of the lot, is used to store waste oil. According to BIPCO representatives, this building is referred to as the “DEM Building” due to its storage of waste oil. Several 55-gallon containers of used/waste oil are temporarily stored here. The containers are emptied into an approximate 2,000-3,000- AST, which is situated within a concrete containment pad. A concrete lined collection pit is located adjacent to the AST and is utilized in the event of a spill. Petroleum was observed at the base of this pit. The concrete slab appeared to be in generally sound condition; however, heavy petroleum staining was observed throughout the building. **SAGE recommends collection of groundwater samples from active monitoring wells located in proximity to the “DEM Building” to evaluate whether there has been any objectionable impact to groundwater as a result of the waste oil storage.**

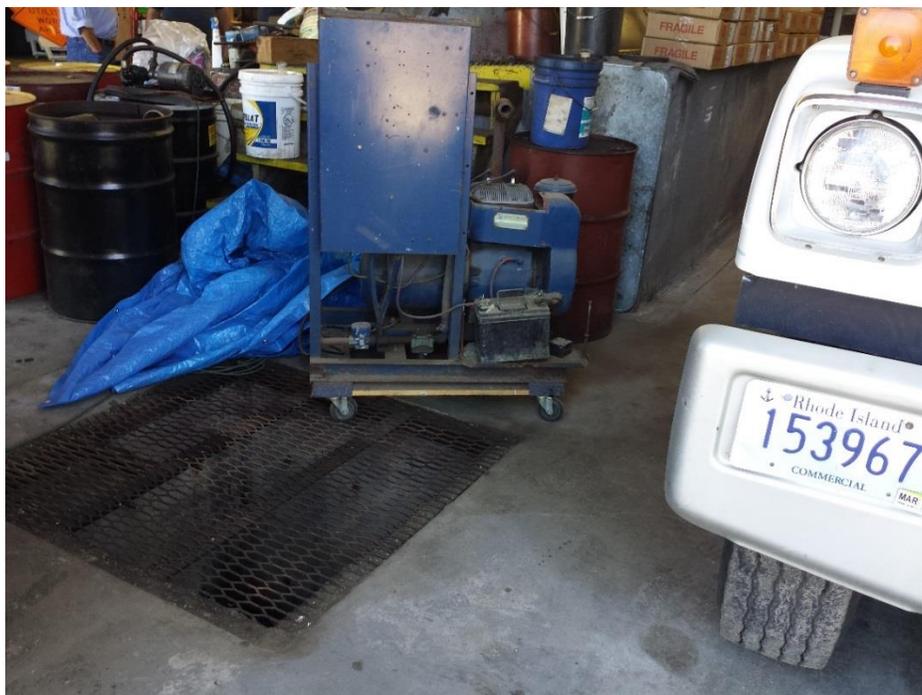
View of the collection pit in the “DEM Building”. Please note oil was present in the put at the time of the inspection.

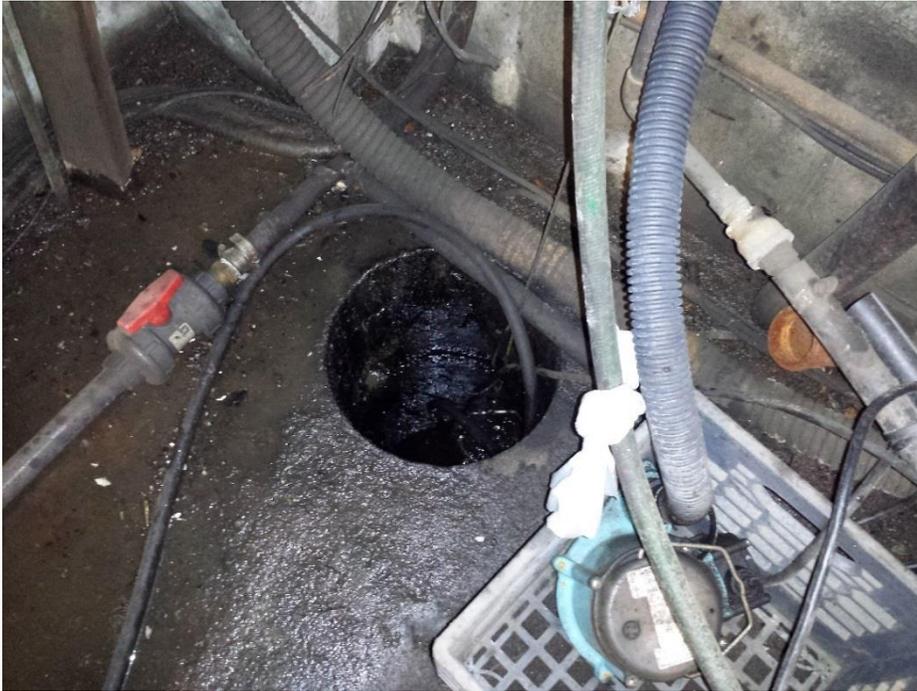
- The smaller, westernmost generator building currently houses two (2) generators. Petroleum staining was noted on the concrete floor and in collection sumps located adjacent to the generators.

View of a collection sump located within the westernmost generator building. Please note the heavy petroleum staining surround the sump.

- “Two (2) Generator Buildings” – Based on the storage and use of petroleum products in these buildings and petroleum staining observed throughout the two (2) buildings, this is considered an environmental concern to the Site. **SAGE recommends collection of groundwater samples from active monitoring wells located in proximity to the generator buildings to independently determine if there has been any objectionable impact to groundwater.**

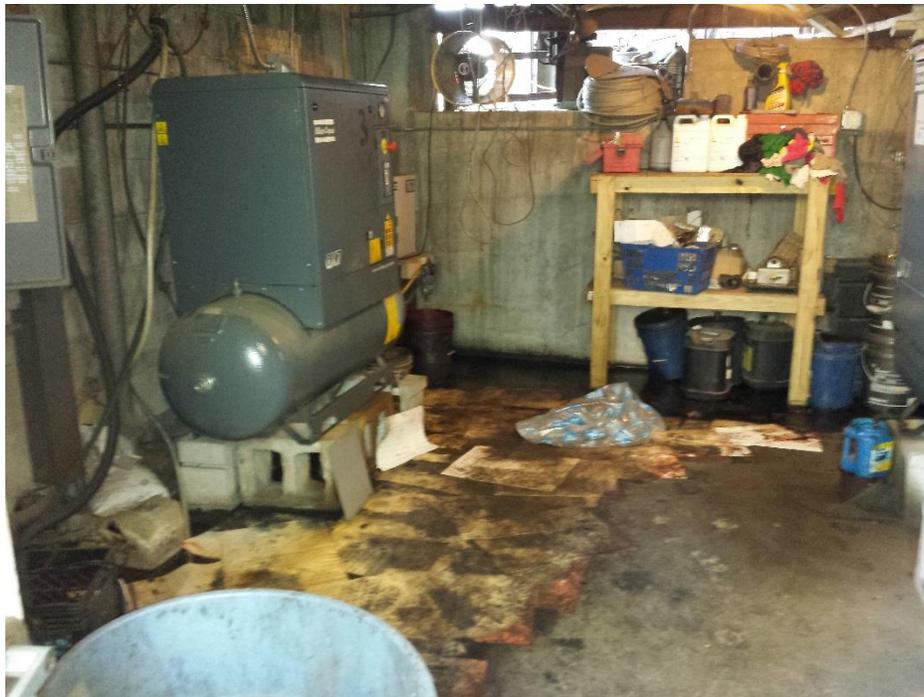
- Due to a recent fire, full access to the larger, easternmost generator building was limited. According to interviews with BIPCO representatives, a piston on one of the engines shot through the engine block which caused hot oil to spill on the ground of the larger generator building and ignite a fire. Upon limited inspection by SAGE, petroleum staining was observed throughout the partial basement. Oil absorbent pads were observed on the floor of the building. According to BIPCO representatives, a full cleanup of the spilled petroleum has not been completed due to restricted access to the building. This building houses three (3) generators.

View of the area of the easternmost generator room affected by the fire.

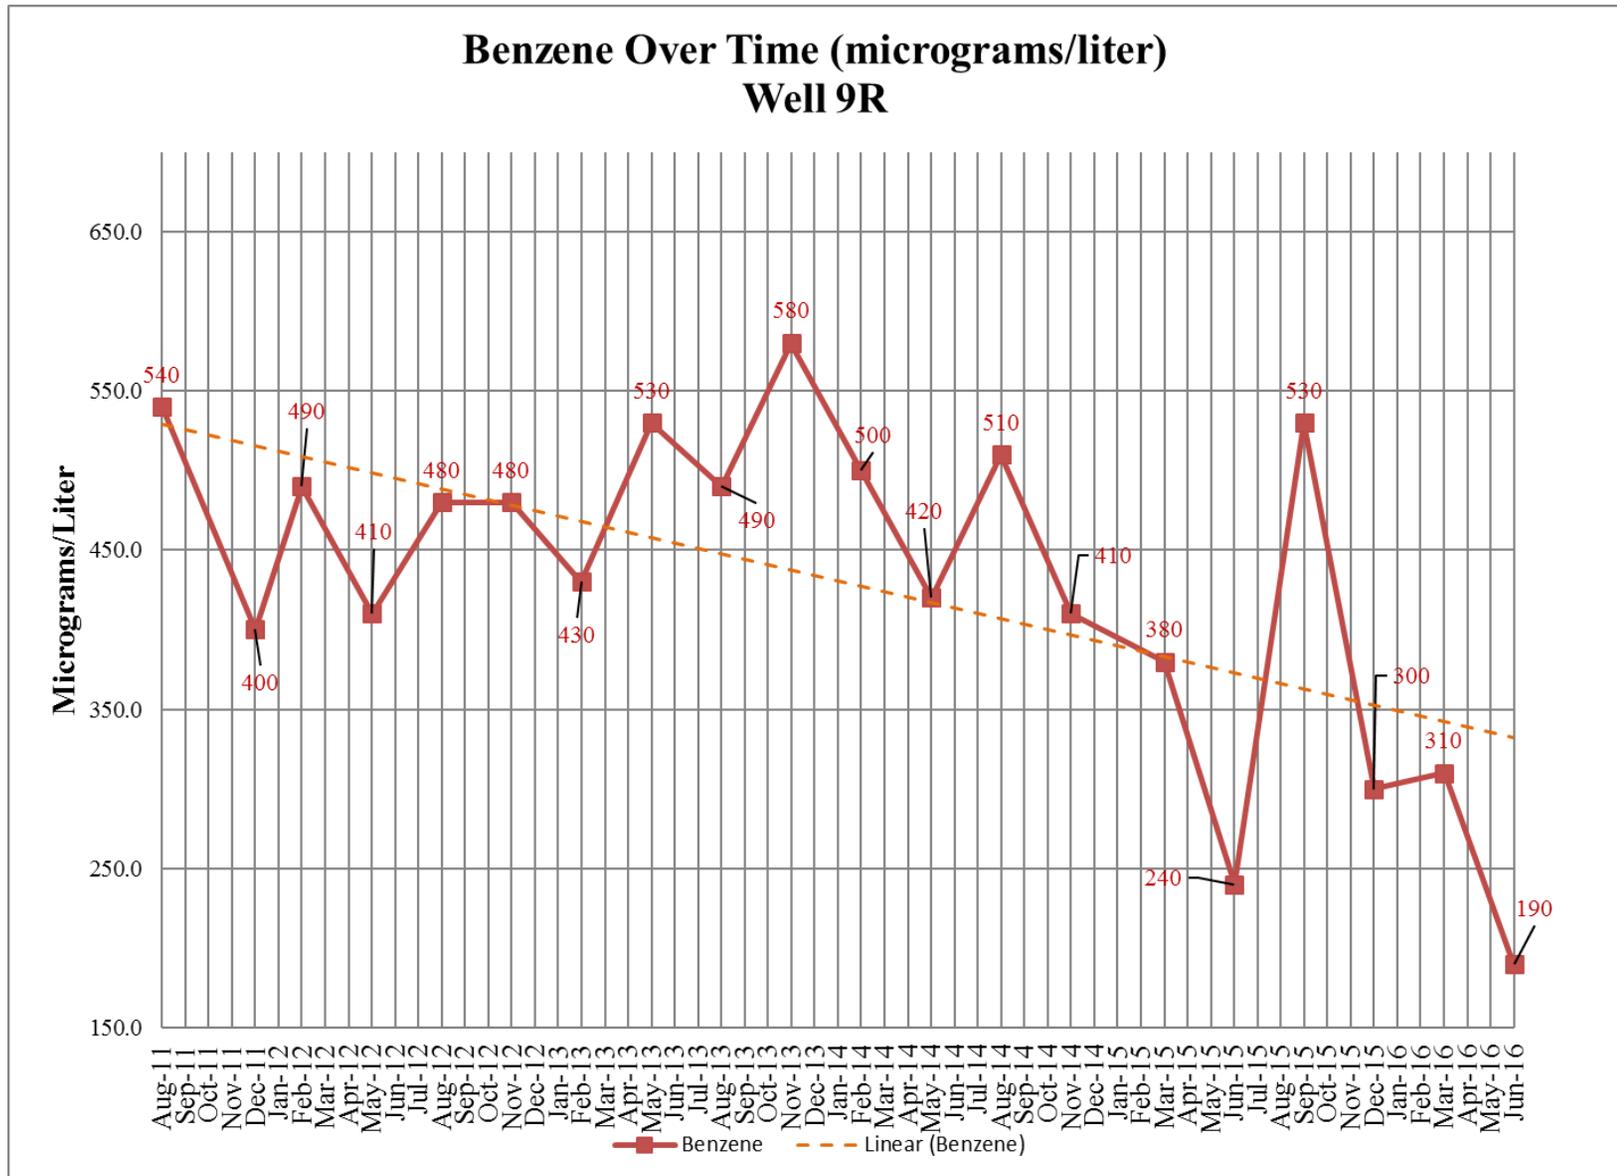
As shown in the chart above, the benzene concentrations measured in Well 9R indicate a substantial decrease since the greatest concentrations were sampled in 2010 and 2011, when the well was relocated closer to the former source of contamination. Results of the past 20 quarterly sampling events indicate that benzene fluctuations may be gradually decreasing, as shown by the linear trend line in the chart above.
